NBS CIRCULAR 550

**Mechanical Failures
of Metals in Service**

For many years the National Bureau of Standards has made examinations of metal parts that have failed in service for evidence bearing on the causes of failure. Thirty-five such cases, representing the most frequently observed types of failures are described, and the factors of design, fabrication, or use contributing to these failures are presented. The characteristics by which the various types of fractures can be recognized are discussed, and recommended precautions that should be observed to reduce mechanical failures of metals in service are included.

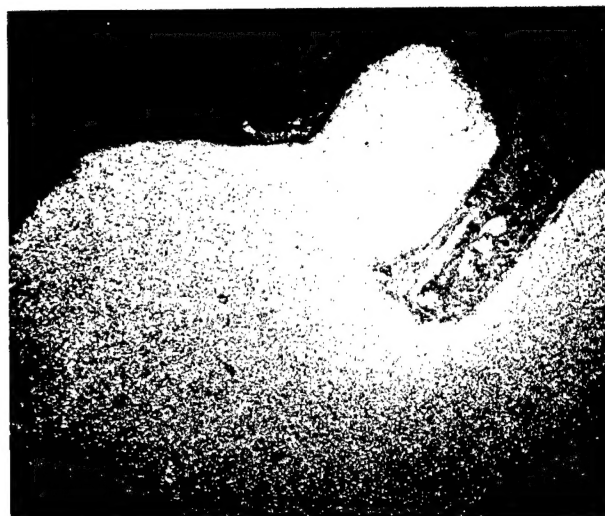
Case 1: Aircraft bolts (steel). The threads stripped before the recommended torque values were reached. The surface of the bolts was decarburized, that is, there had been a loss of carbon from the surface during fabrication or heat treatment. This decreased the strength of the threads to such an extent that they deformed in shear under the normal applied loads. There was some indication of excessive play between the bolt and the nut. This may have been a factor in the failure.

FIGURE 1.2. *Soft decarburized tip of thread that deformed when loaded below the recommended torque.*
Etched with nitric acid in alcohol. $\times 100$.

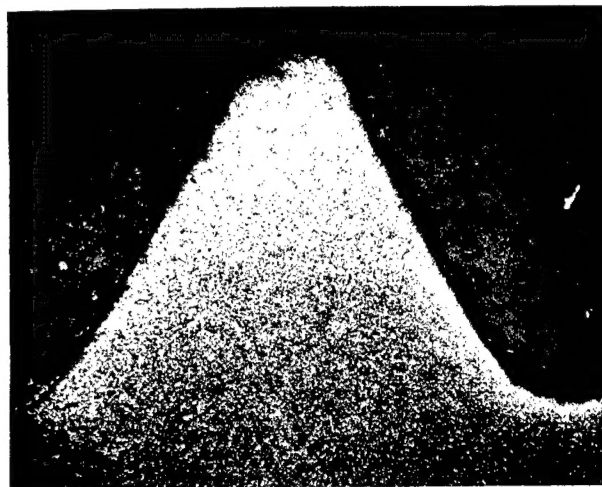
FIGURE 1.3. *Photomicrograph of unused thread, showing depth of decarburization at the tip.*
Etched with nitric acid in alcohol. $\times 100$.

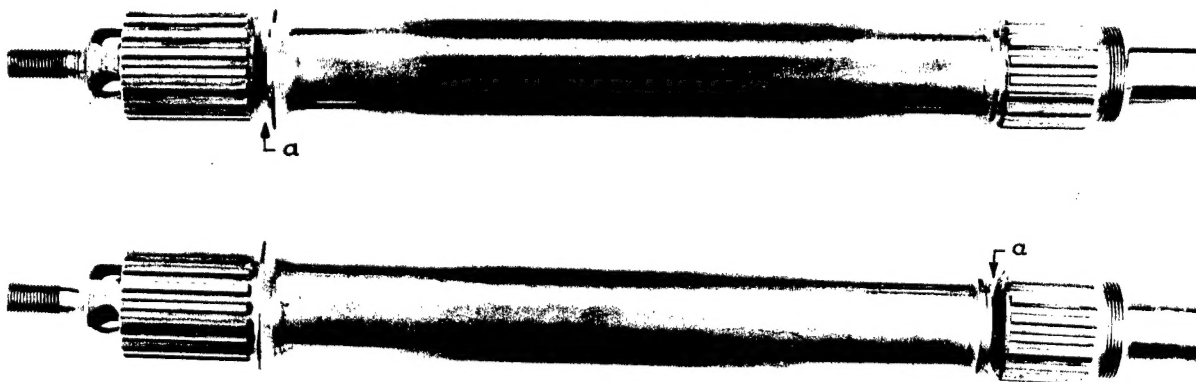
sudden stopping of the engines. The shafts apparently failed owing to the excessive torque applied to them when the propellers were stopped by impact with the ground. This example is included to show the type of fracture found in ductile materials subjected to torsion. The absence of deformation remote from the fracture is due to the stress concentrating effect of the grooves and the high rate of loading. This fracture might easily have been mistaken for fatigue, but on close examination of the fracture surfaces it was evident that the metal had been extensively deformed in shear.

FIGURE 3.1. *Accessory drive shafts fractured at arrows a*

The geometry of the parts and the high rate of loading localized the deformation in the grooved portions of the shafts, which were nearly identical at the two ends. The torsion load caused no dimensional change in the shaft before fracture such as a tension load would have caused. $\times \frac{1}{2}$.

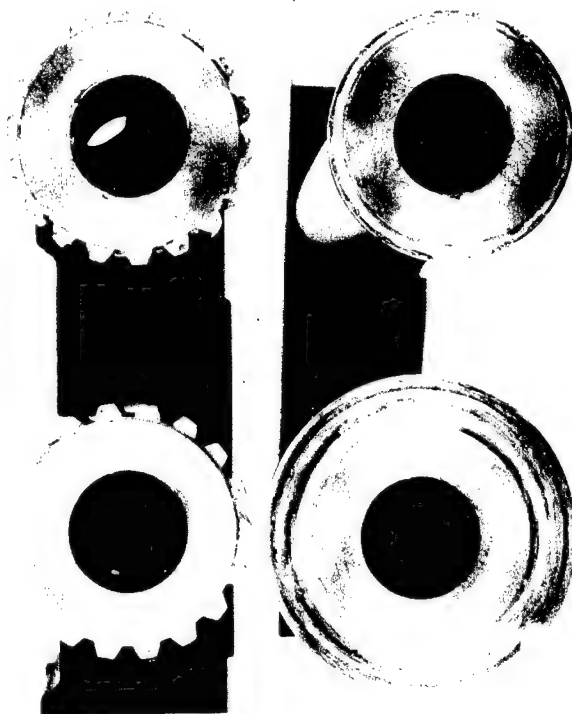
FIGURE 3.2. *Surfaces of the fractures.*

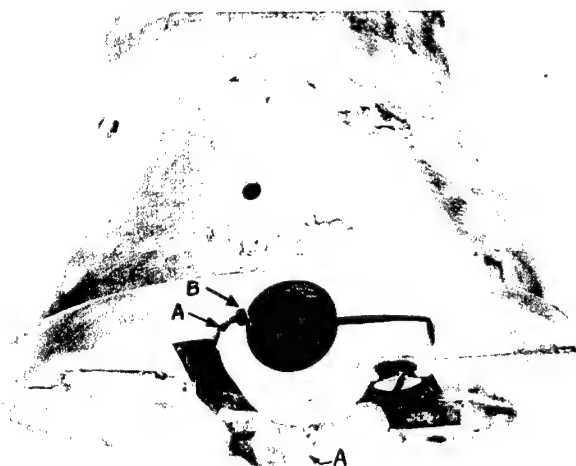
at the back of the clamp acted as points of stress concentration that would reduce the strength of the relatively brittle casting. In addition, the casting was of poor quality, containing numerous voids.

FIGURE 4.1. *Aluminum-alloy ankle casting.*

The fractures, A, occurred at the back of the clamp where the key grooves, B, reduced the cross section. $\times 1$.

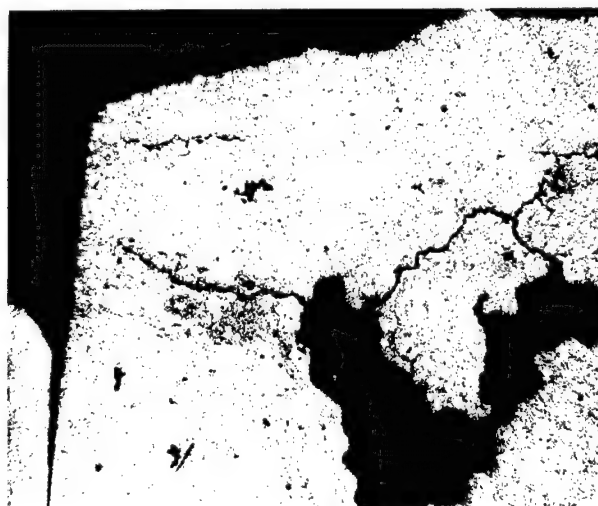
FIGURE 4.2. *Section perpendicular to the fracture (top) showing porosity, which greatly reduced the strength of the casting.*

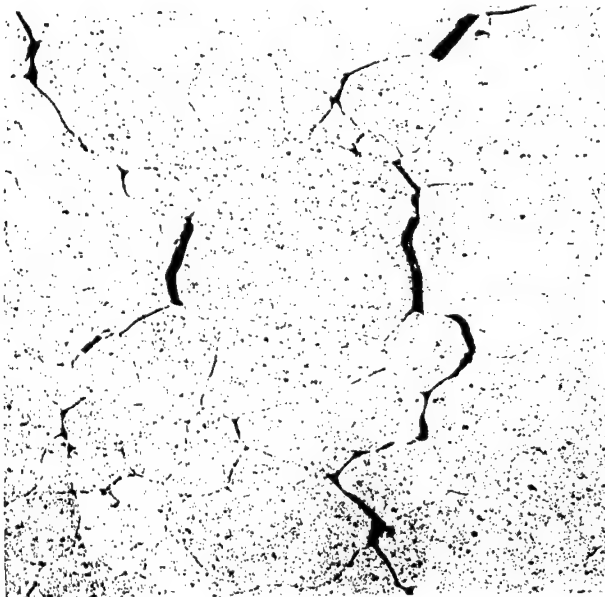
FIGURE 5.2. Microstructure on a longitudinal section of the tube near the fracture shows numerous intergranular cracks that are typical of material that has been subjected to stress at high temperature.

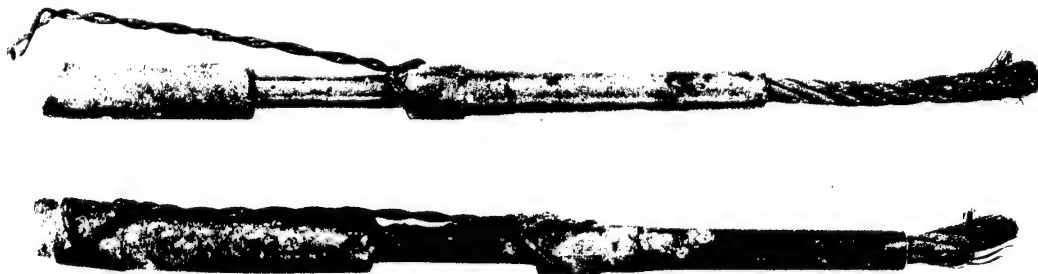
Case 6: Turnbuckle from aircraft control system (brass). Removed from an airplane that had been involved in an accident. It was evidently not the primary failure. The part had broken while heated to a very high temperature. The fracture surface shows extremely coarse grains and little ductility. The temperature at the time of failure was sufficiently high to reduce the strength of the grain boundaries in the metal, which resulted in fracture, with little or no ductility.

FIGURE 6.1. Parts of two broken turnbuckles removed from a crashed airplane. $\times 1$.

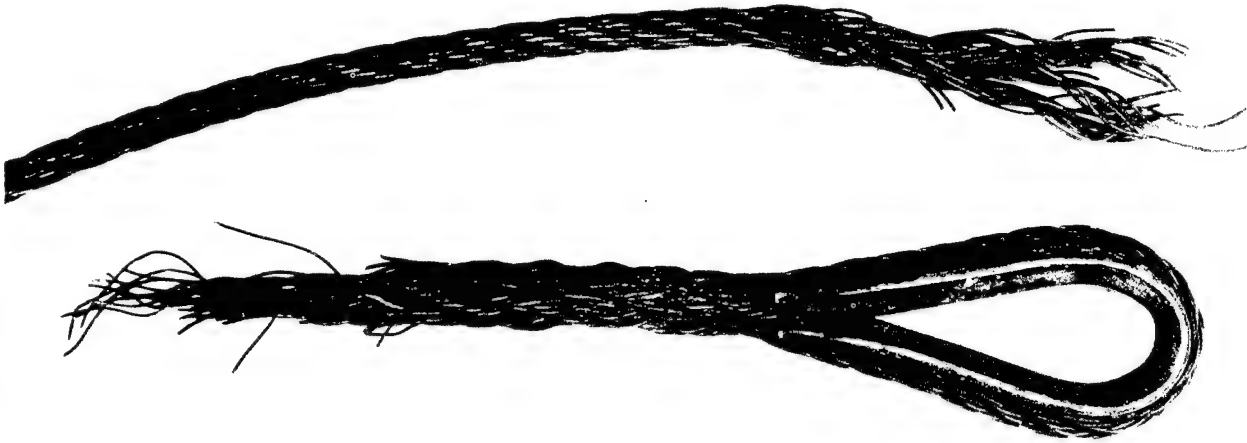
completely alter the microstructure, resulting in much lower strength. This weakened portion of the wire was unable to withstand the normal applied loads and failed in a ductile manner.

FIGURE 7.1. Broken rudder cable. $\times 3$.

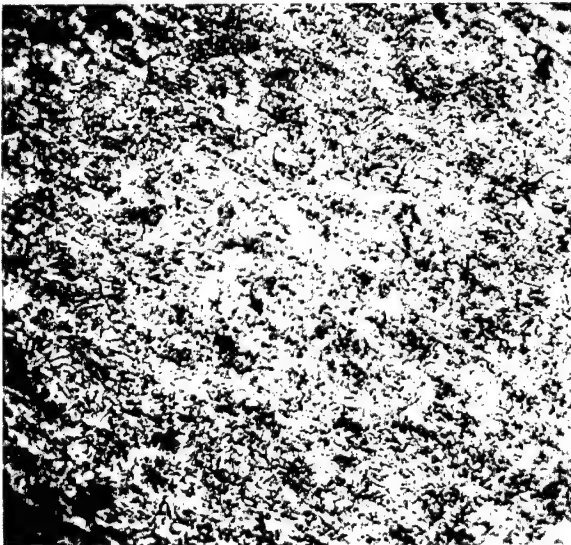
FIGURE 7.2. Microstructure of a longitudinal section of a wire near the fracture indicates that this portion of the cable had been heated sufficiently to spheroidize the carbides and reduce the strength of the cable.

Etched with nitric acid in alcohol. $\times 1000$.

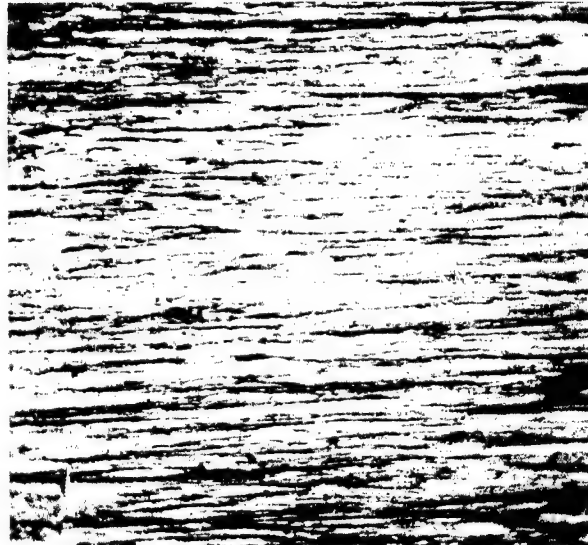
FIGURE 7.3. Microstructure of a longitudinal section of a wire 2 feet from the fracture shows the normal structure of severely cold-drawn steel wire.

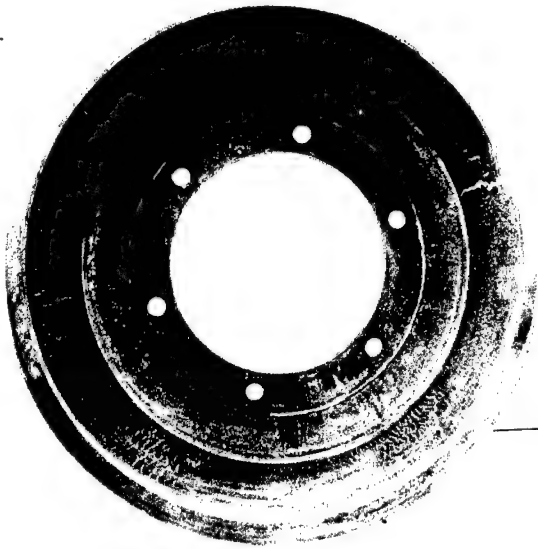
iron to martensite in some spots. As martensite occupies more volume than pearlite, the transformation set up high internal stresses in the metal, which, combined with the applied stress, were sufficient to cause cracking adjacent to the transformed areas. This type of cracking is often referred to as heat checking.

FIGURE 9.1. *Cracked brake drum, as received.*

The cracks are easily visible because of the brake lining material that had been scraped off and forced into them. $\times \frac{1}{16}$.

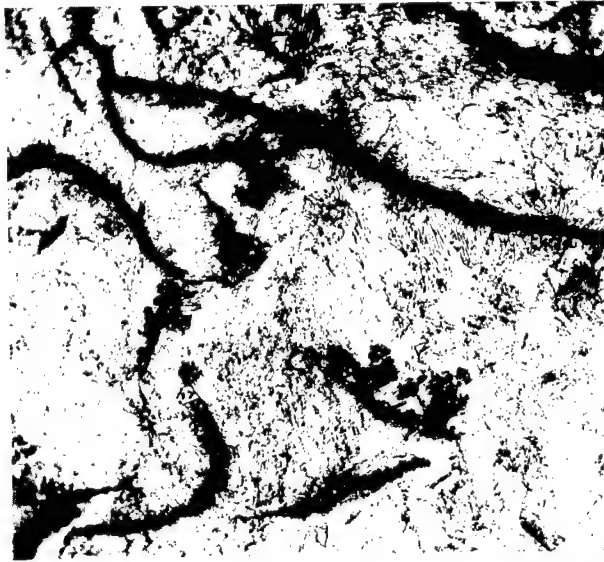
FIGURE 9.3. *Typical microstructure in the interior of the drum.*

Graphite flakes are interspersed through the pearlite matrix. Etched with nitric acid in alcohol. $\times 500$.

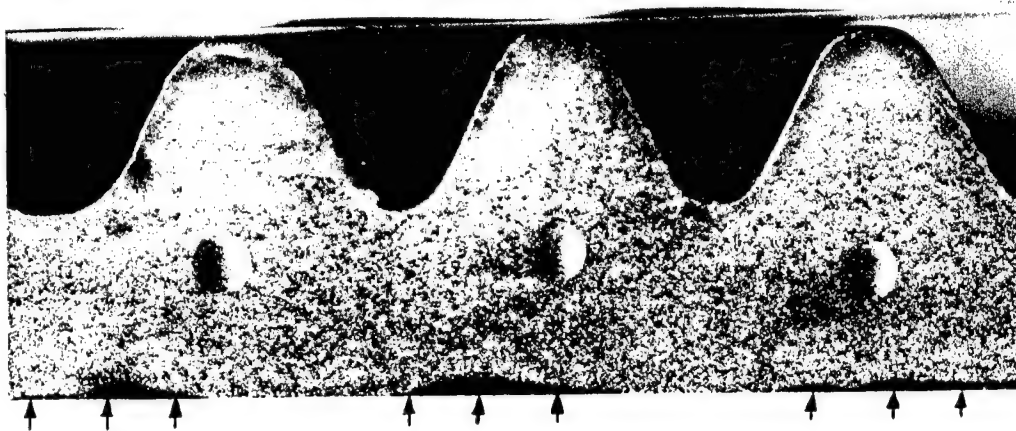
FIGURE 9.2. *Etched section of drum showing numerous transformed areas (dark) indicated by arrows along the inner surface at bottom.*

The hardness of the original material was 265 Vickers, whereas that in the dark areas was as high as 450 Vickers. $\times 2$.

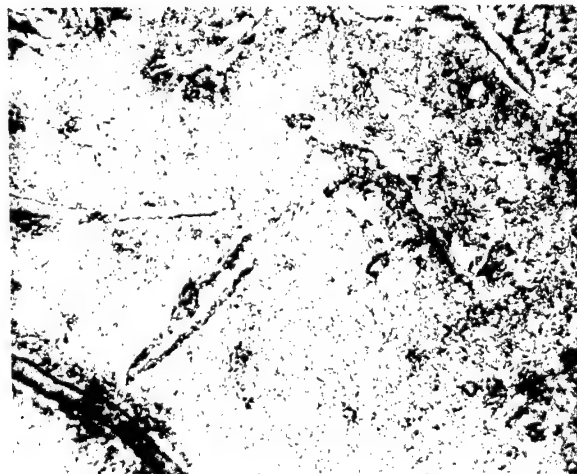
FIGURE 9.4. *Microstructure in the dark-etching areas along the inner surface of the drum.*

The pearlite has transformed to hard, brittle martensite. Etched with nitric acid in alcohol. $\times 500$.

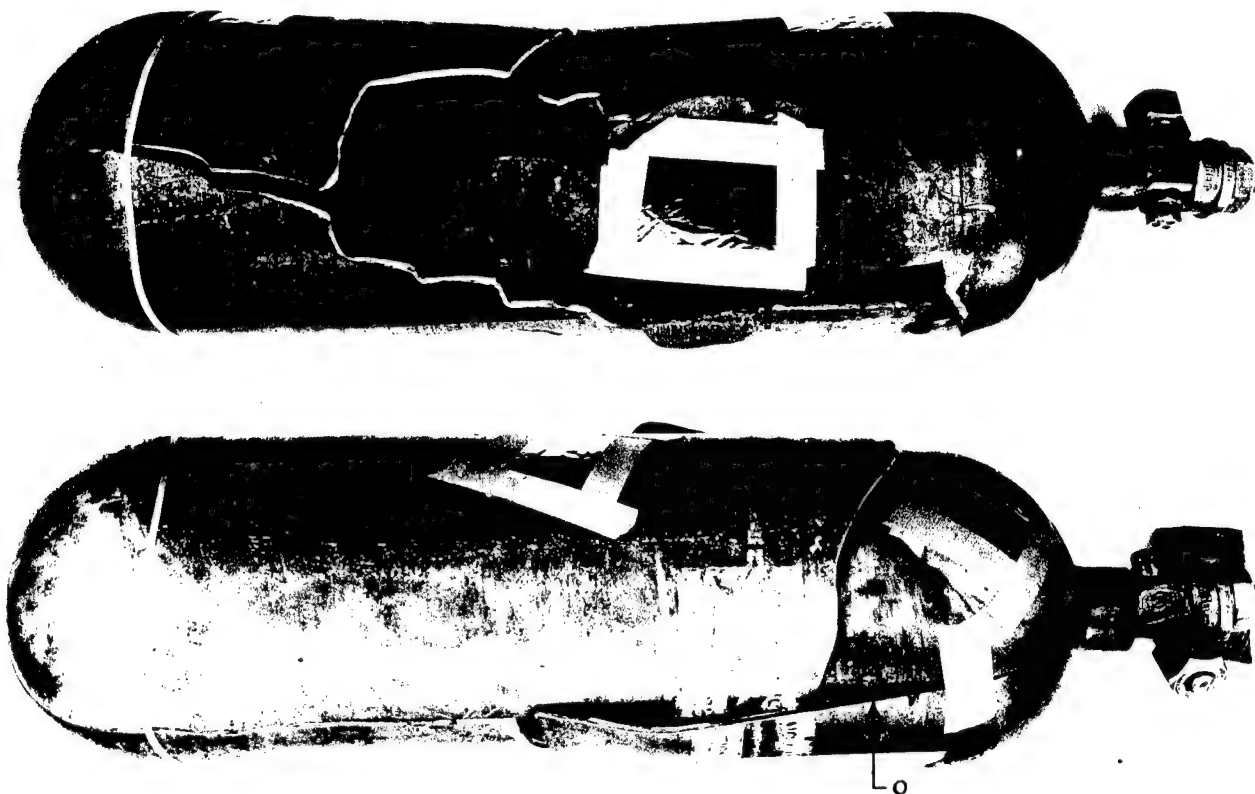
FIGURE 10.1. *Appearance of exploded cylinder with pieces fitted approximately in their original positions.*
By following the indications of the markings on the fracture surfaces, the origin of the fracture was located at arrow O. $\times \frac{1}{4}$.

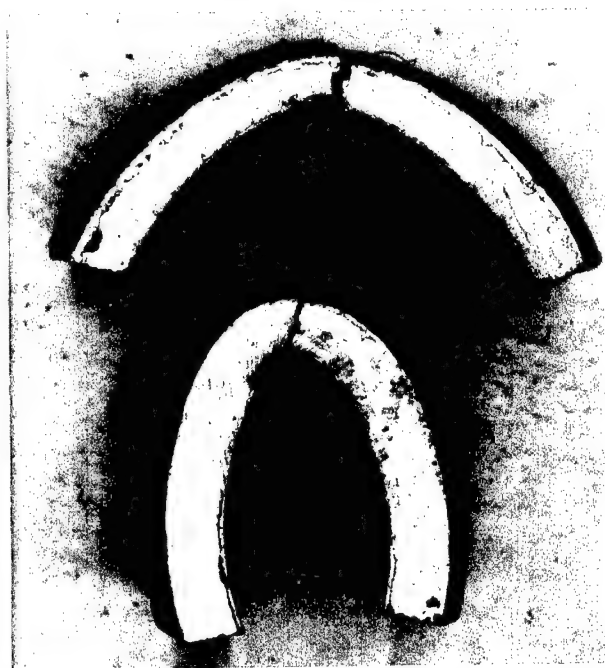
FIGURE 11.3. Bend tests on sections cut from the eye of unused bearings, showing the difference in ductility in different directions.

Top, section cut from top of eye so the bending stress was transverse to the direction of rolling. Bottom section from side of eye. $\times 2$.

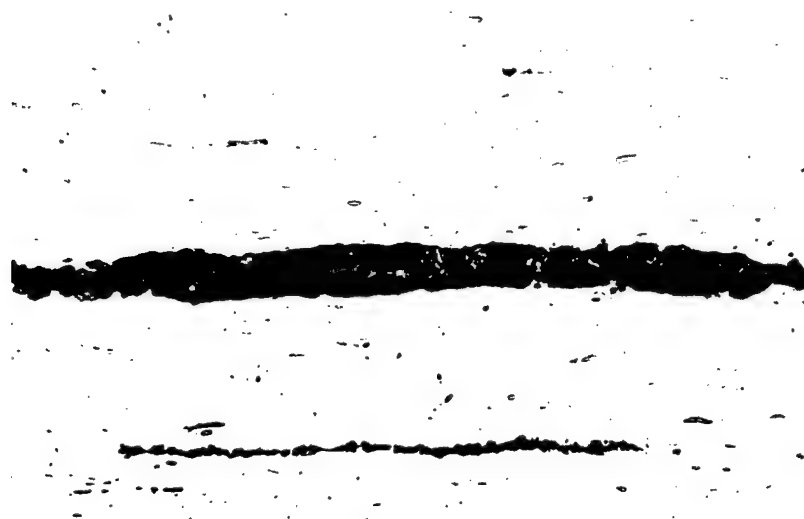
FIGURE 11.4. *Large inclusions observed on a longitudinal section of the steel*
The numerous small inclusions shown in this micrograph are typical of those found on all sections examined. No etch. $\times 100$.

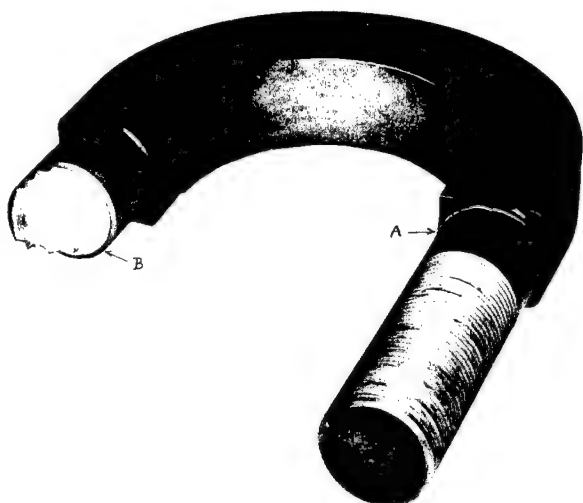
stress at fracture was only 30,000 lb/in.² It was found that the piece contained numerous intergranular cracks, probably due to improper forging practice or heat treatment. In addition, the hardness and strength of the steel were much higher than that specified, (45 Rockwell C compared to a specified value of 34) with consequent greater brittleness. The combination of these factors reduced the strength of the part much below that of sound material of lower hardness.

FIGURE 13.1. *Fractured yoke with the initial fracture, A fitted together.*
The fracture at B resulted from the eccentric loading after the initial fracture. $\times \frac{1}{16}$.

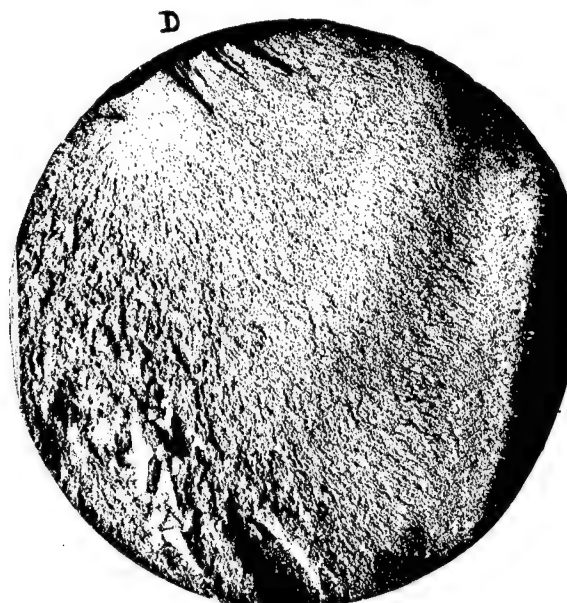
FIGURE 13.2. *Surface of the initial fracture.*
The dark area near D is a crack that occurred during fabrication or heat treatment, and caused the brittle fracture under load. The darkening is due to oxide scale, which shows that the steel was heated to a high temperature after the cracks were formed. $\times 1$.

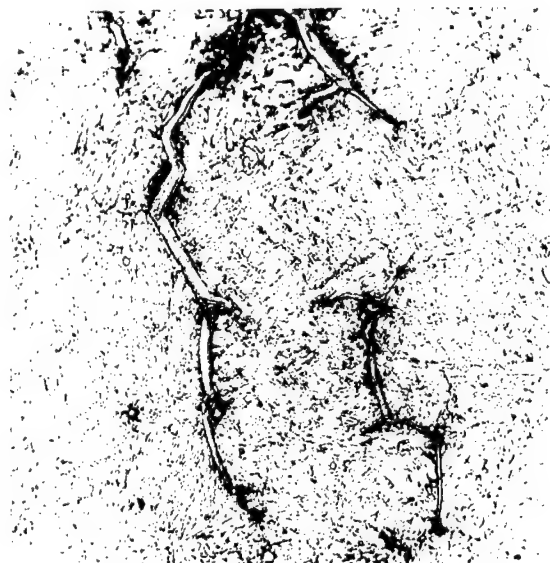
FIGURE 13.3. *Inner end of a crack similar to those which caused the fracture.*
The path of the crack appears to be along the boundaries of prior austenitic grains, which is typical of cracks due to improper forging or quenching. Etched with nitric acid in alcohol. $\times 500$.

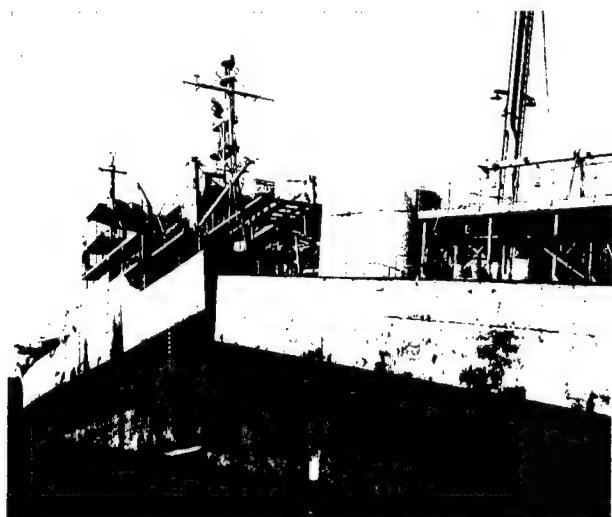
FIGURE 14.1. Tanker that broke in two at dock, viewed from port side.

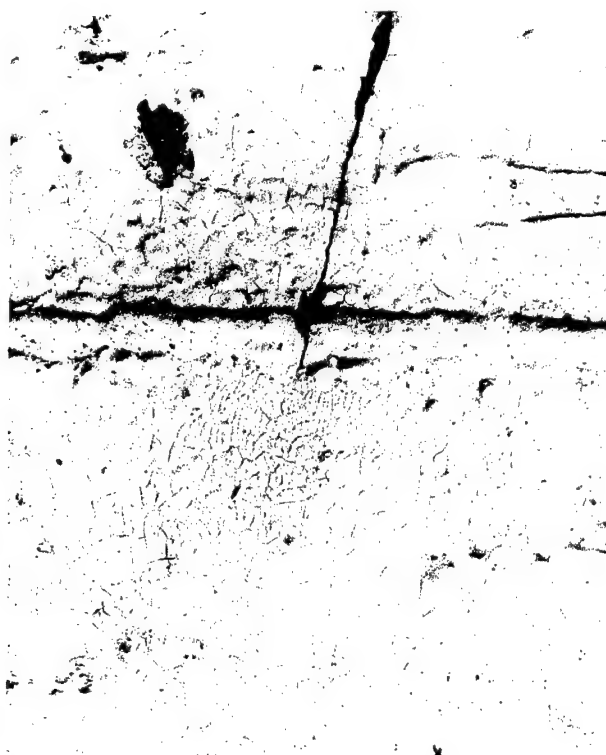
FIGURE 14.3. Area near the end of a fracture.

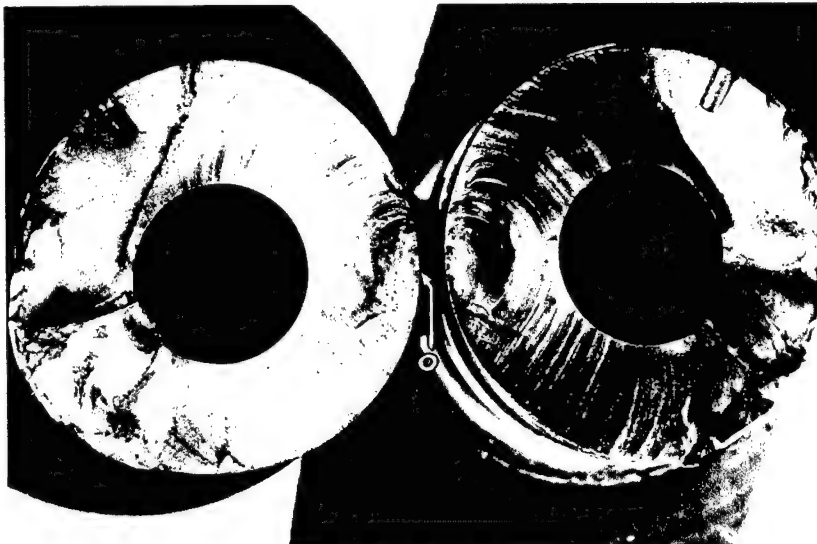
FIGURE 15.3. *Surfaces of the fracture.*

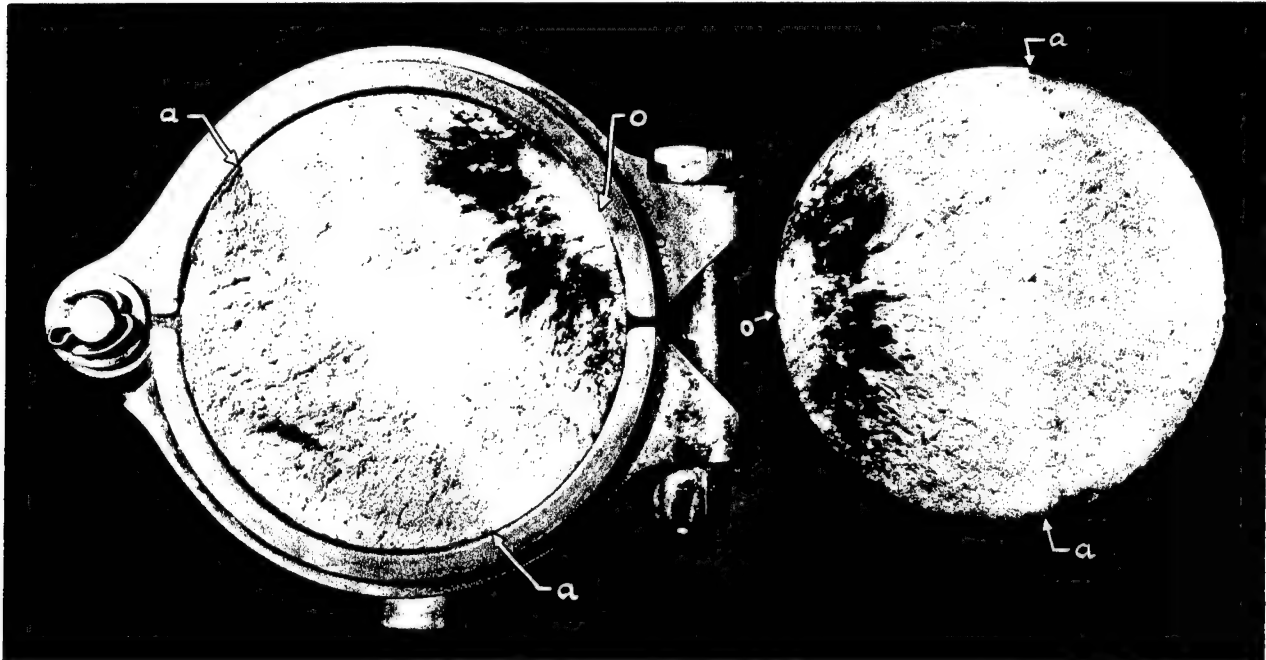
FIGURE 16.1. *Surfaces of the fracture which originated under the hub ring clamp at arrow O.*

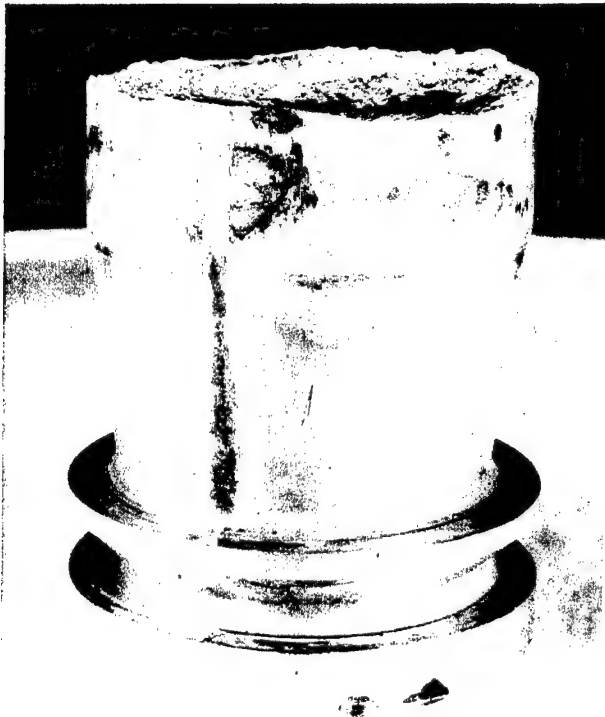
FIGURE 16.2. *Surface of the blade near the origin of the fatigue crack.*

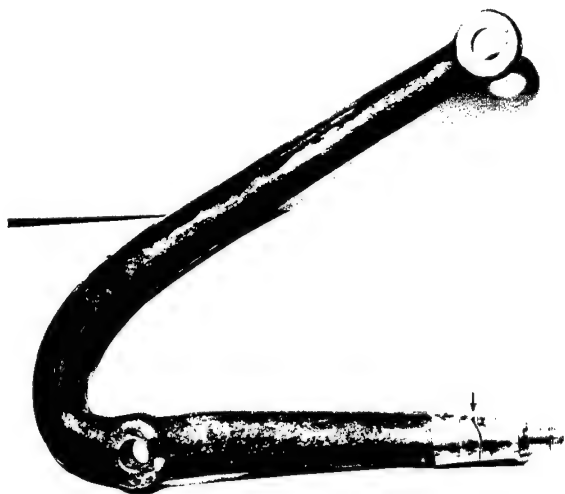
FIGURE 17.1. Broken steering arm from a highway truck. The origin of the primary fatigue crack is indicated by the arrow. $\times 14$.

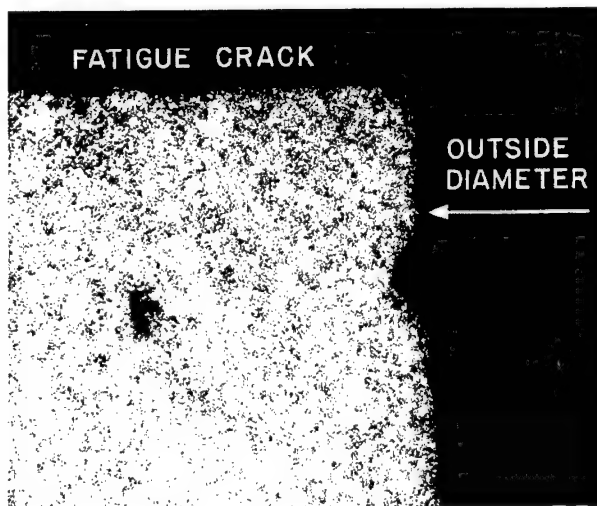
FIGURE 17.3. Longitudinal section of the arm near the origin of the fatigue crack.

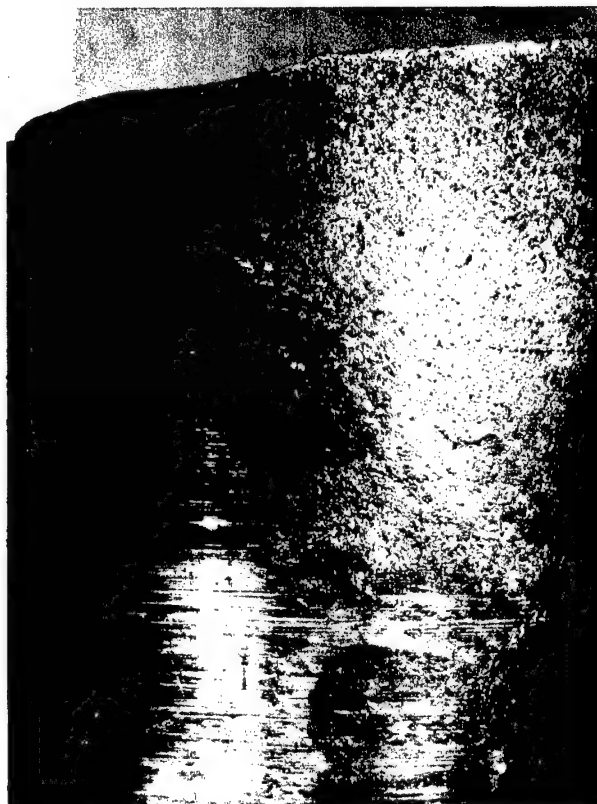
FIGURE 17.4. Surface of the arm near the origin of the fatigue crack.

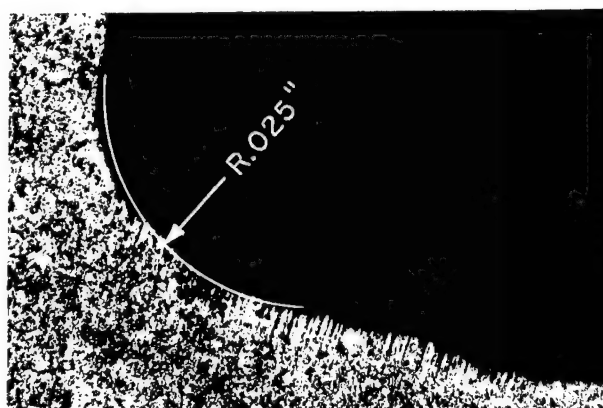
FIGURE 19.2. Section through the intersection of the cut-out and the cylinder, showing the sharp corner with a minimum radius of approximately 0.025 inch. $\times 50$.

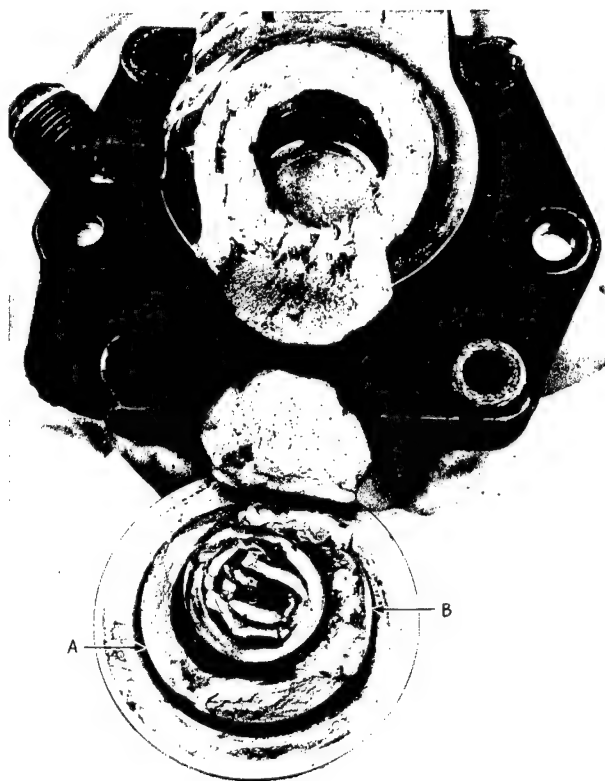
FIGURE 20.1. *Fractured fitting as received.*

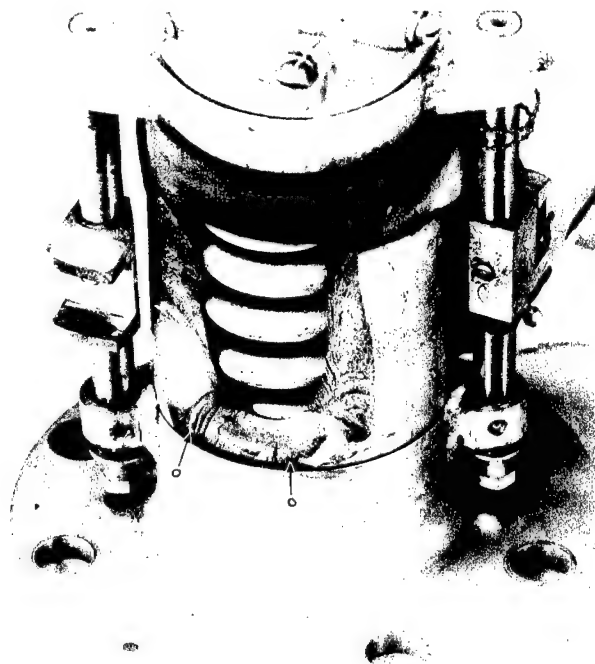
FIGURE 21.1. *Surface of the fracture in the propeller hub where the arm holding one blade broke completely out of the hub.*

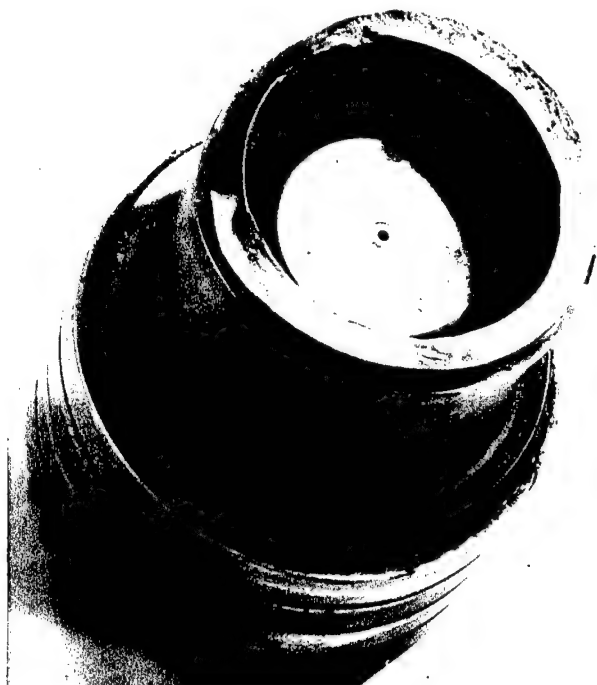
FIGURE 22.1. Hub end of the fractured blade. $\times \frac{1}{2}$.

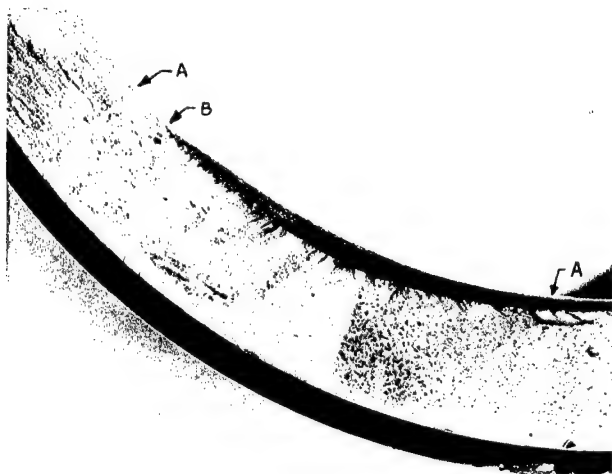
FIGURE 22.2. Fracture surface near the origin of the fatigue crack.

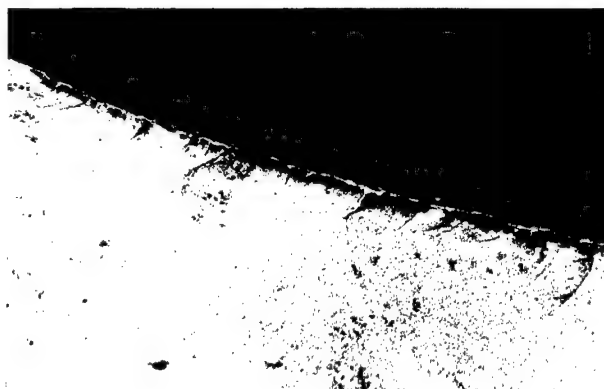
FIGURE 22.3. Surface of the fatigue crack adjacent to the indentation.

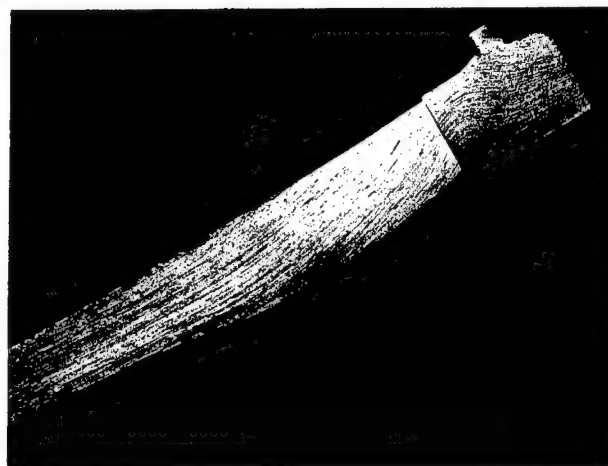
FIGURE 22.4. Longitudinal section of the blade intersecting the fatigue crack.

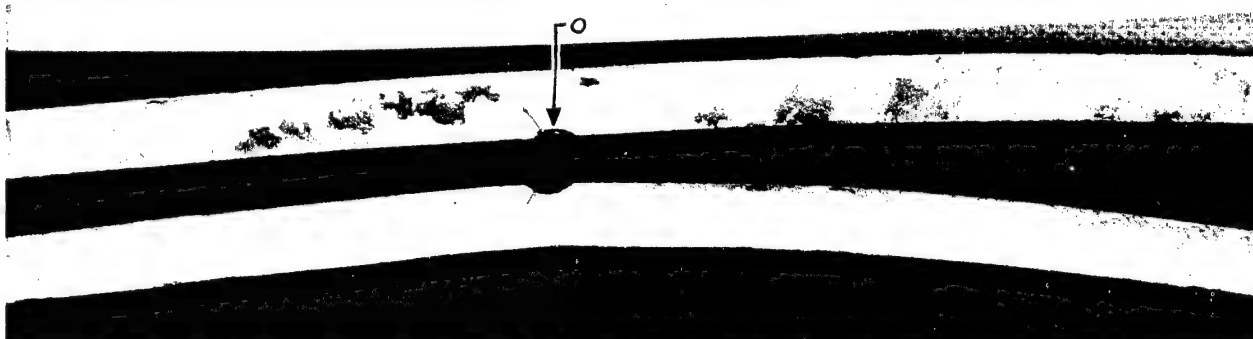
FIGURE 23.2. *Fracture surfaces near the origin of the fatigue crack, arrow O. $\times 3$.*

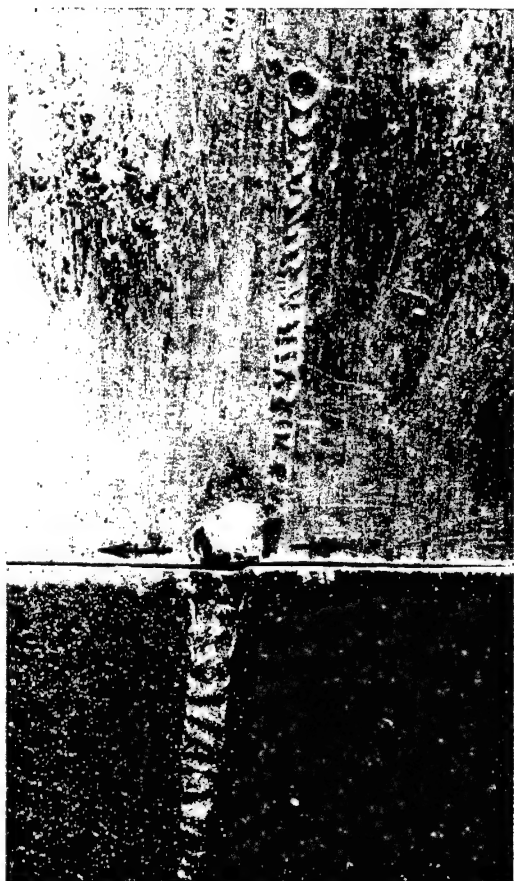
FIGURE 23.4. *Longitudinal section through the defect shown in figure 23.3.*

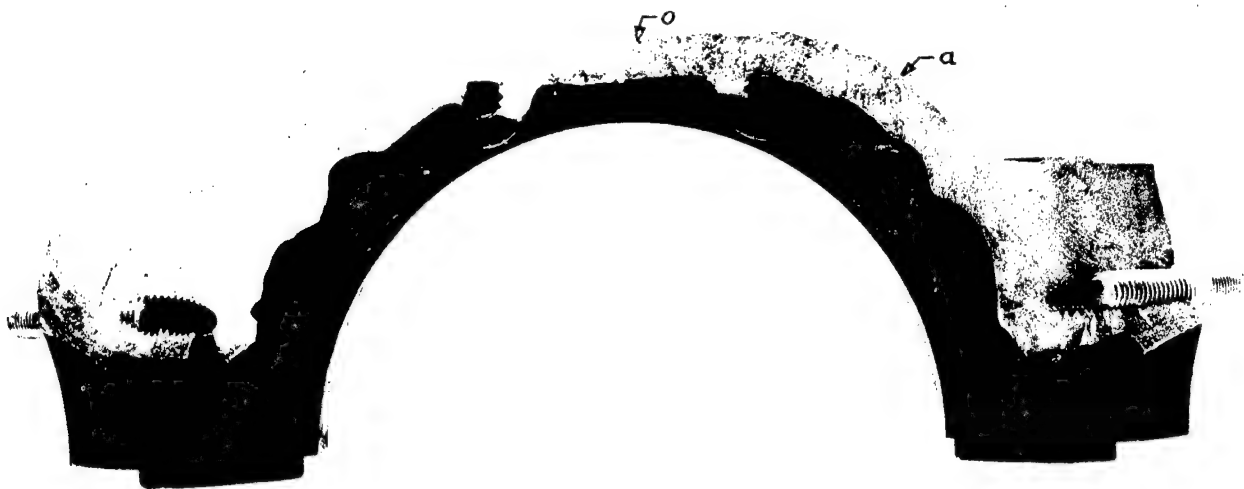
FIGURE 24.1. *Surface of the fracture in the cylinder pad.*

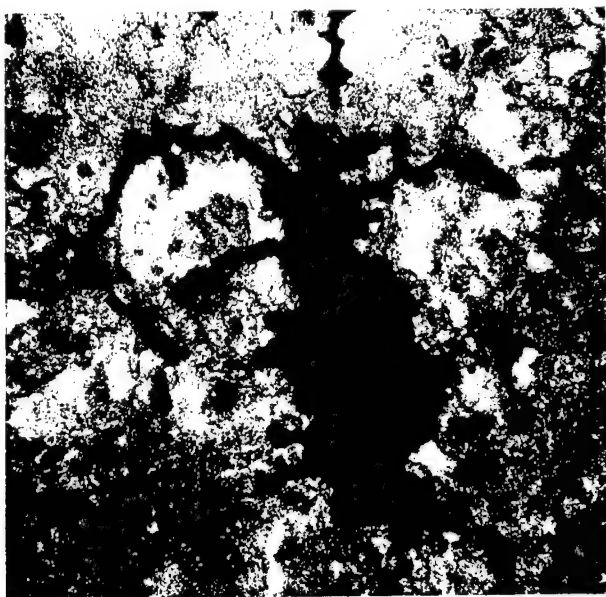
FIGURE 24.2. *Microstructure of the metal in the porous zone near the origin.*

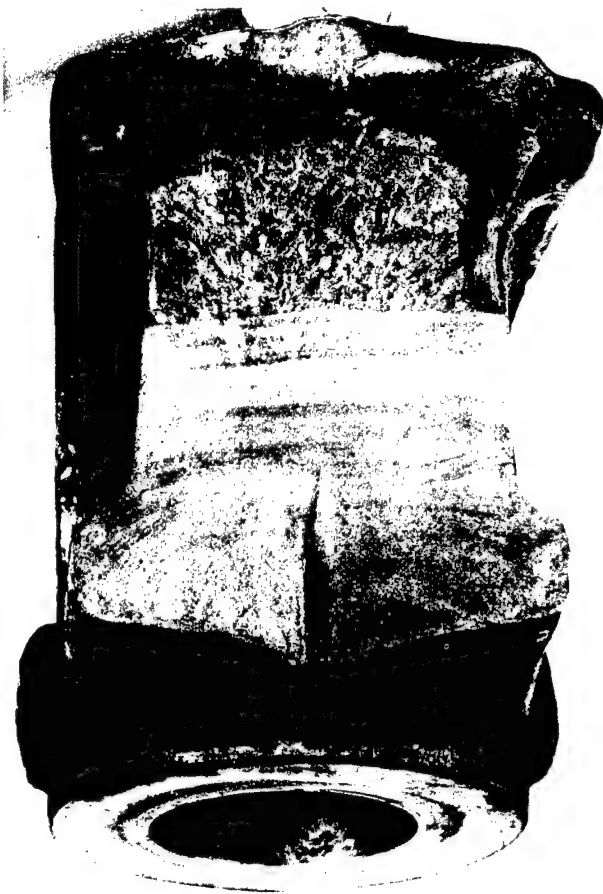
FIGURE 28.1. *Surface of fracture in front axle.*

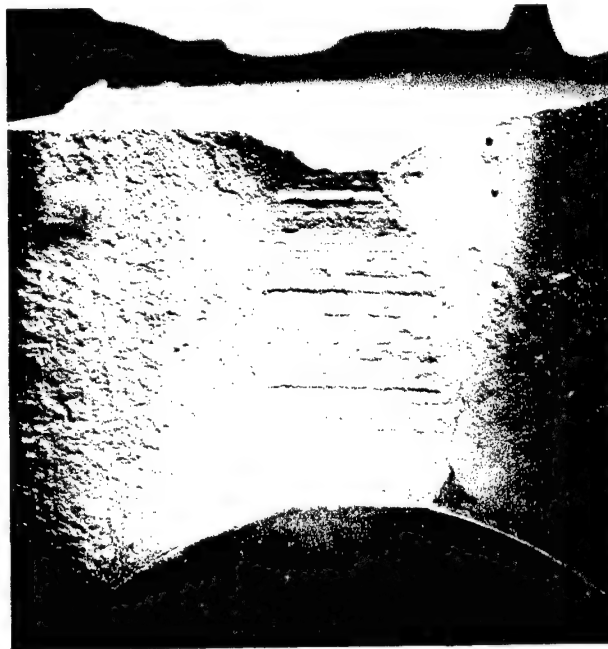
FIGURE 28.2. *Bottom surface of the axle adjacent to the fracture, showing the transverse grooves apparently due to shearing off the forging flash.*

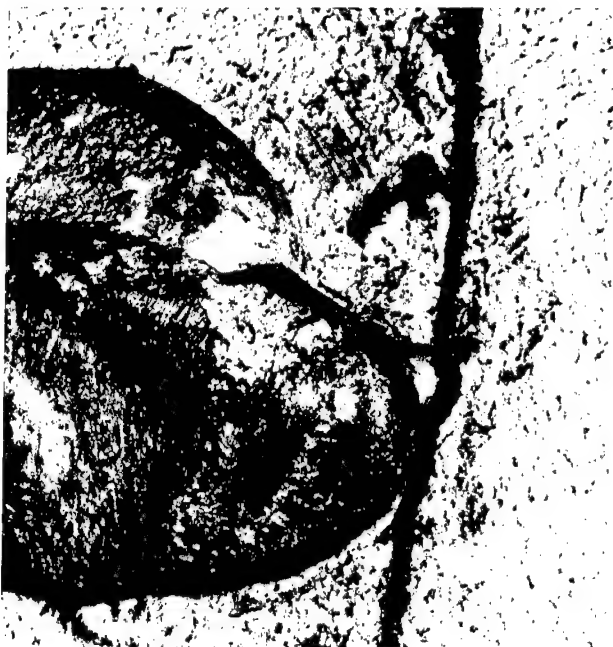
FIGURE 29.1. Surface of the fractured spar tube showing the origin of the fatigue crack at the toe of a weld. $\times 5$.

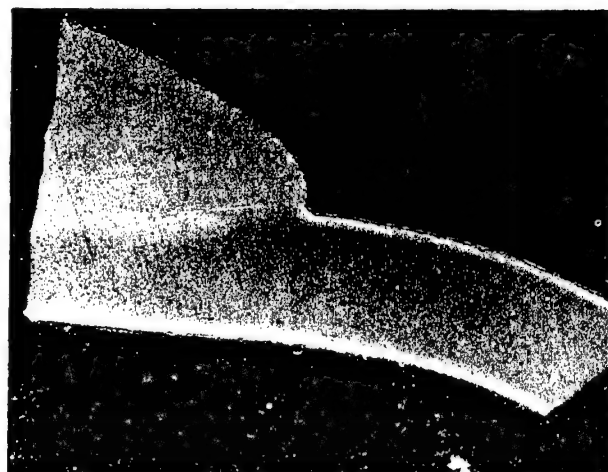
FIGURE 29.2. Transverse section of the tube and weld inboard of the fracture.

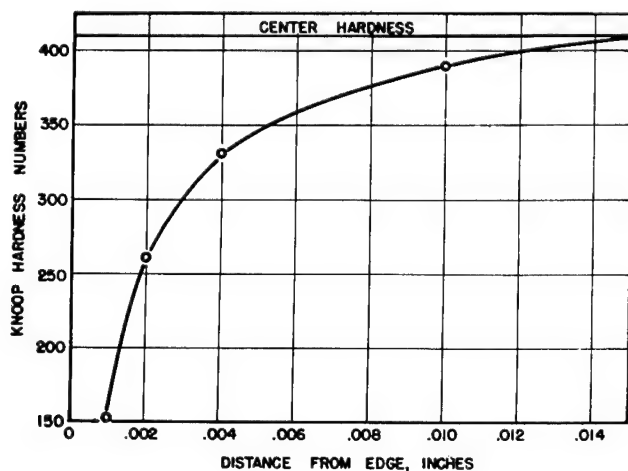
FIGURE 29.3. Results of microhardness measurements made on a cross section of the tube.

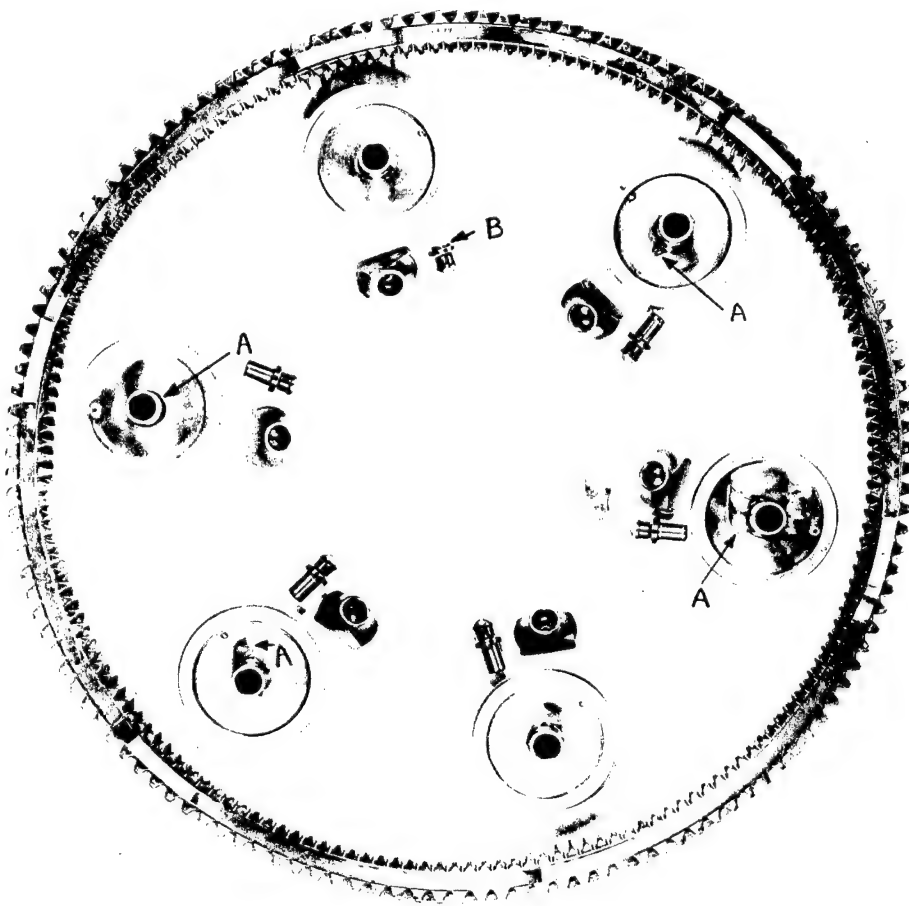
FIGURE 30.1. *Failed torquemeter parts.*

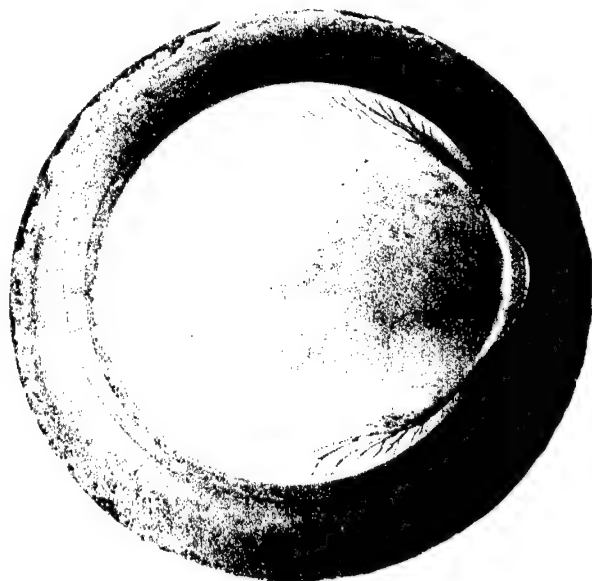
FIGURE 31.2. Surface of the fracture.

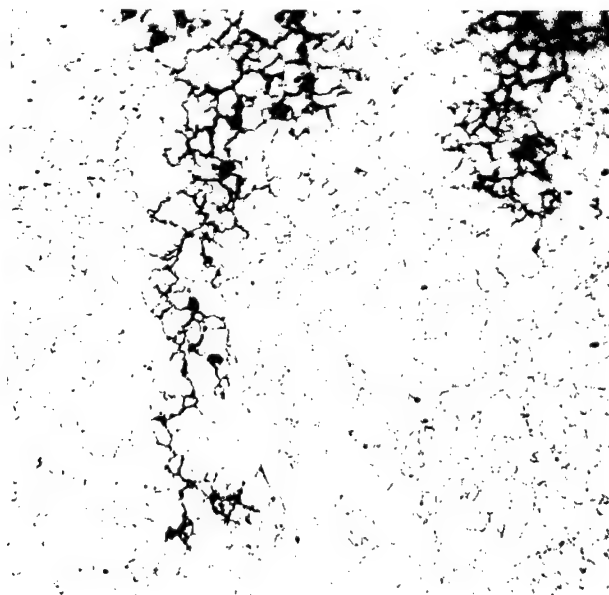
FIGURE 31.3. Transverse section of the plunger near the fatigue fracture.

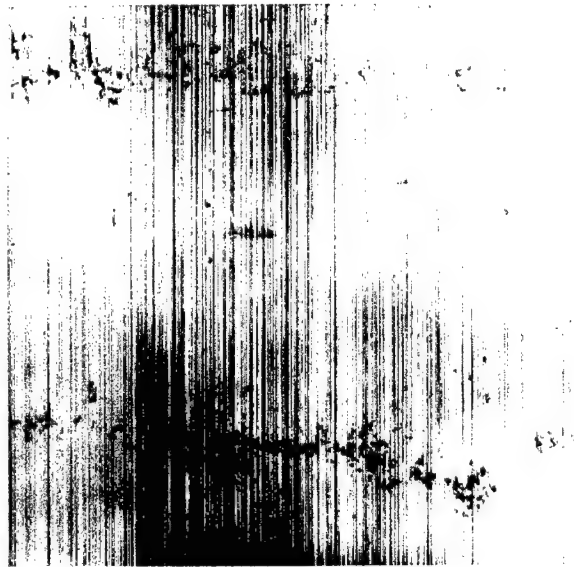
FIGURE 31.4. Corrosion on the surface of the plunger remote from the fatigue crack.

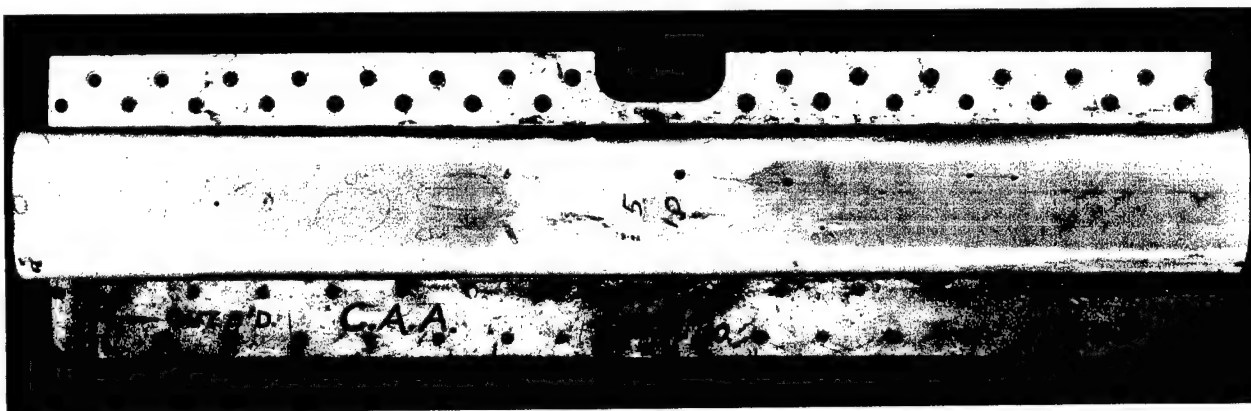
FIGURE 32.1. One of the pieces of cracked spar cap removed from a plane which had been in transoceanic service.

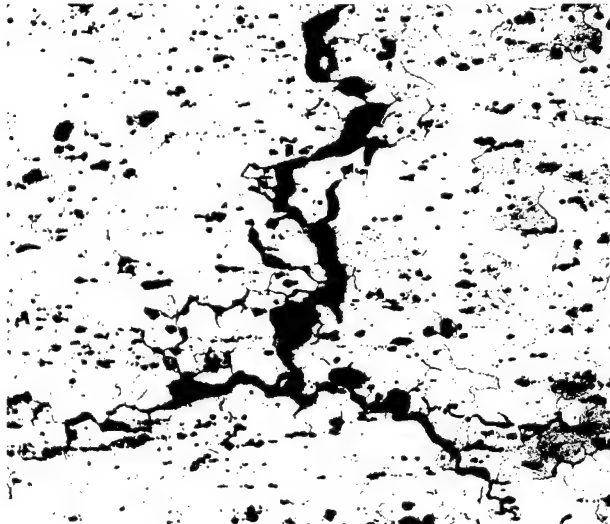
FIGURE 32.4. Photomicrograph showing the intercrystalline path of a crack.
